# MOVING TOWARDS UNIVERSAL ACCESS

## **Accessibility Recommendations for the McBride Train Station**

Apex Access Consultants

# Village of McBride Historic Train Station

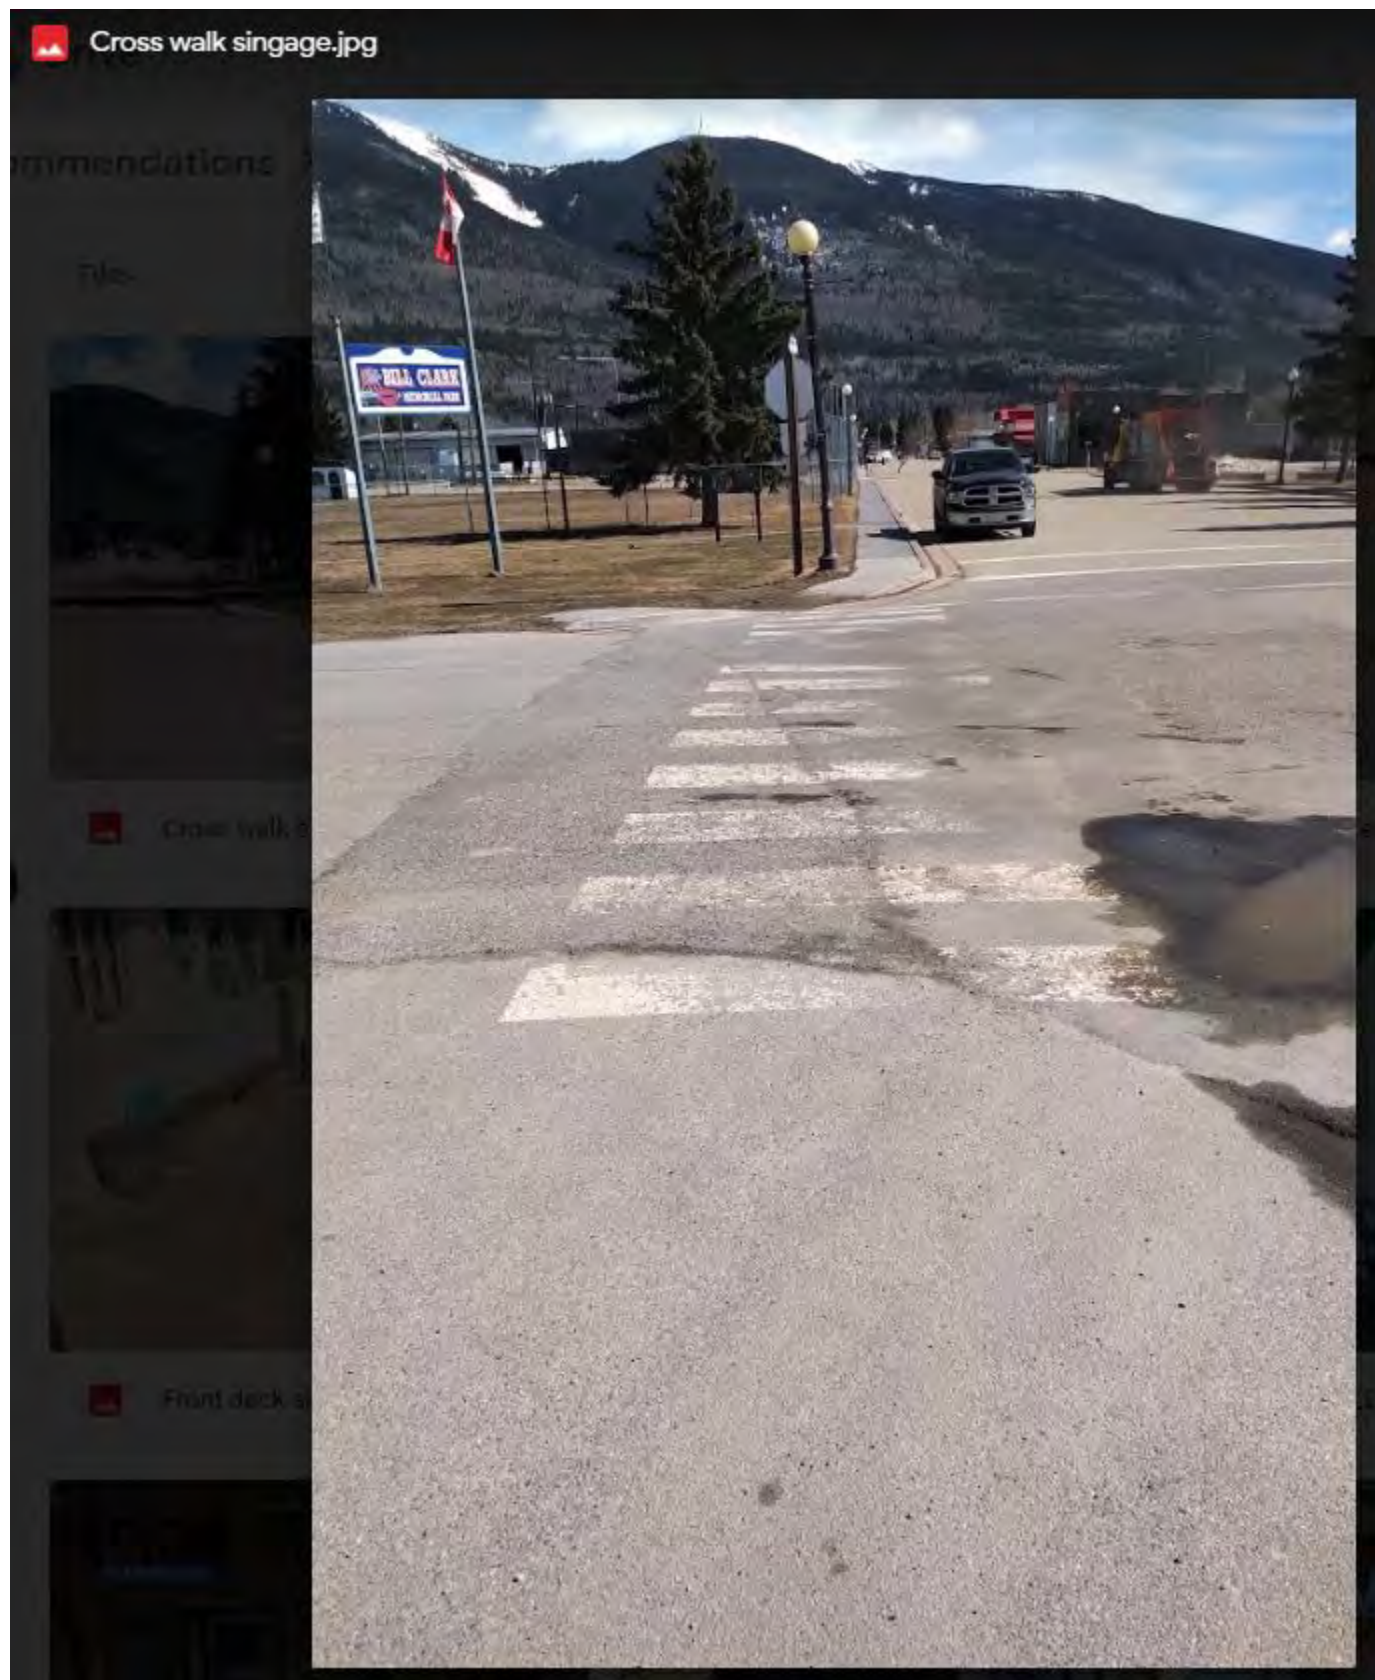
EXTERIOR PATHWAY – Cross Walk Signage

- The pathway from the village main street has crosswalks indicated on the pavement but lack clear vertical signage to ensure safe crossing. It is recommended the addition of signage to indicate the crossings. It is also recommended that a pedestrian pathway (crosswalk) be painted on the Parking Lot asphalt to indicate a path from the crosswalk to the facility. This can be accompanied by vertical signage.

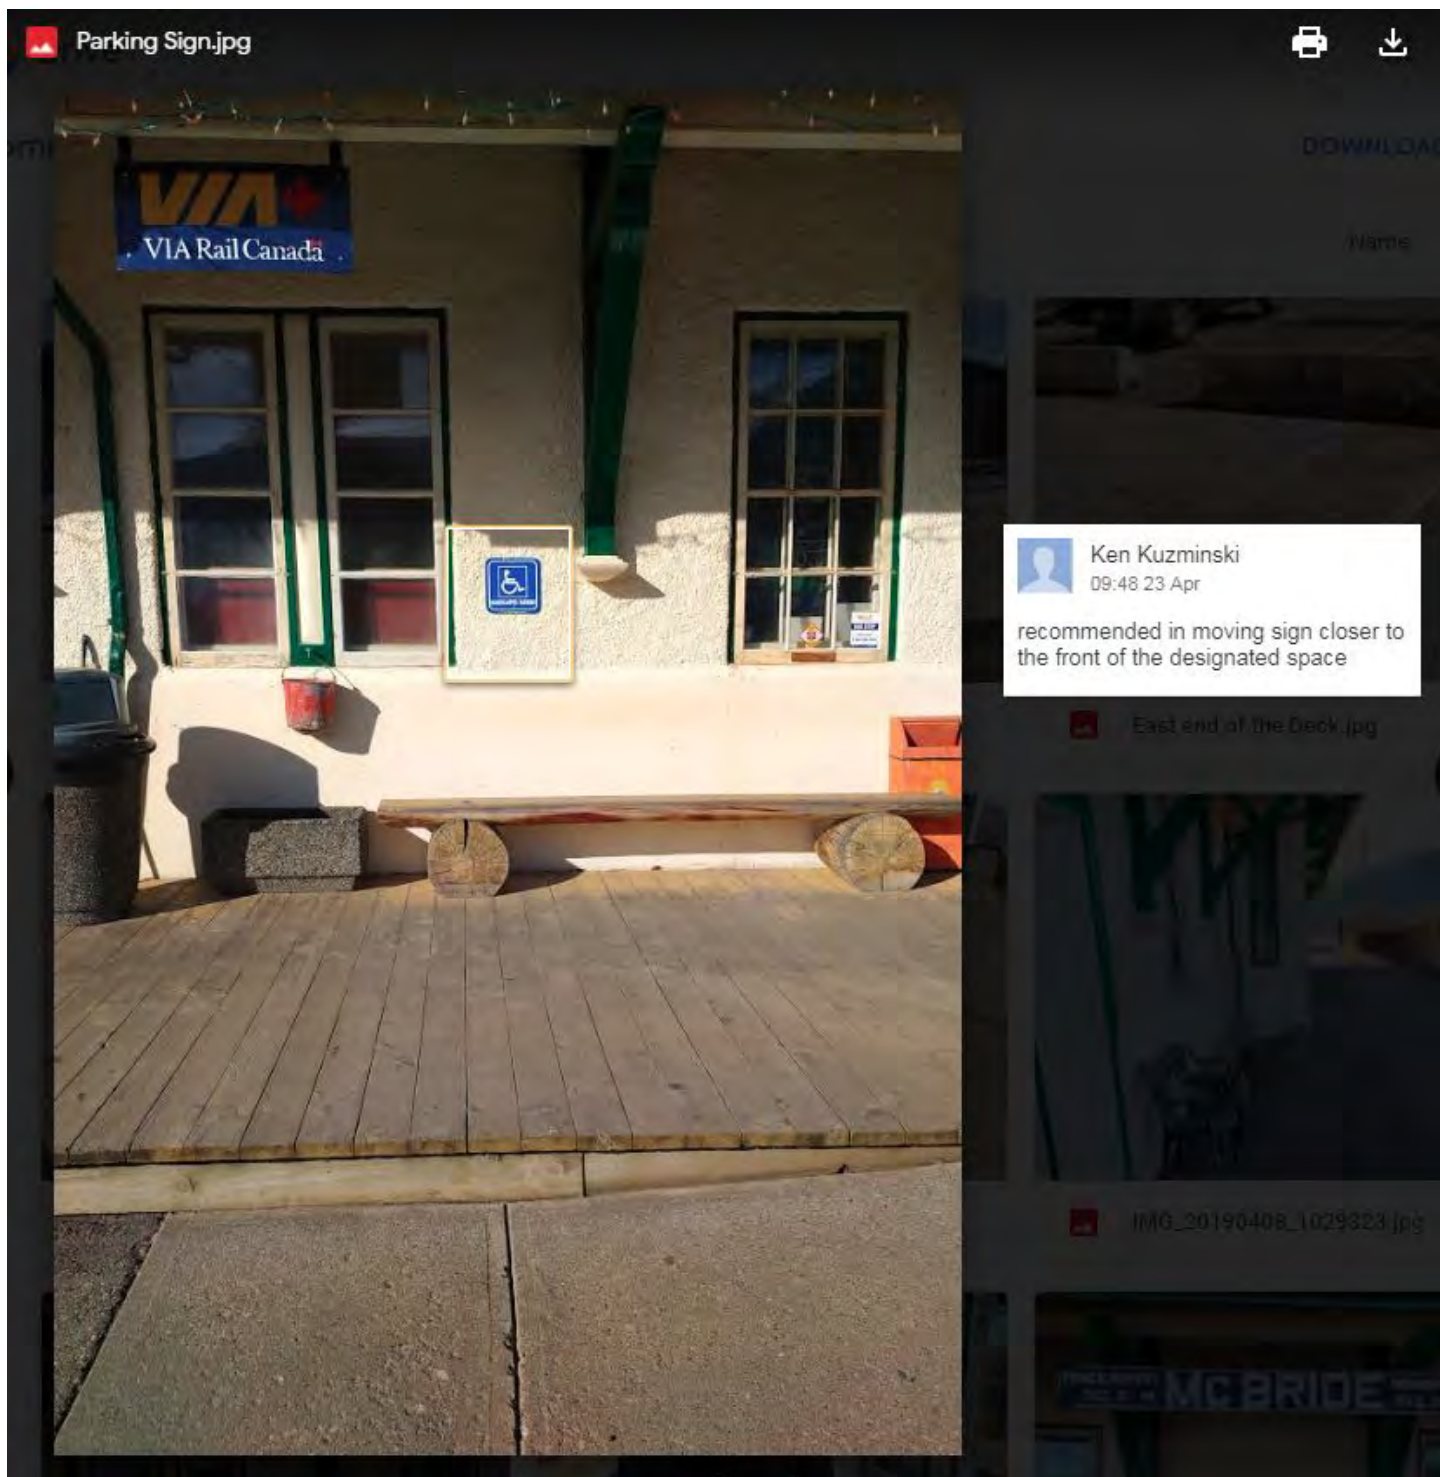
EXTERIOR PATHWAY – Parking Sign

- The Parking Lot is currently well designed for the designated space. Currently the space provided can accommodate a designated space with an Access Aisle. To increase accessibility, it is recommended that the designated space to have vertical signage directly in front of the space. The current sign on the building is a fair distance away and is not intuitive to acknowledge the space.

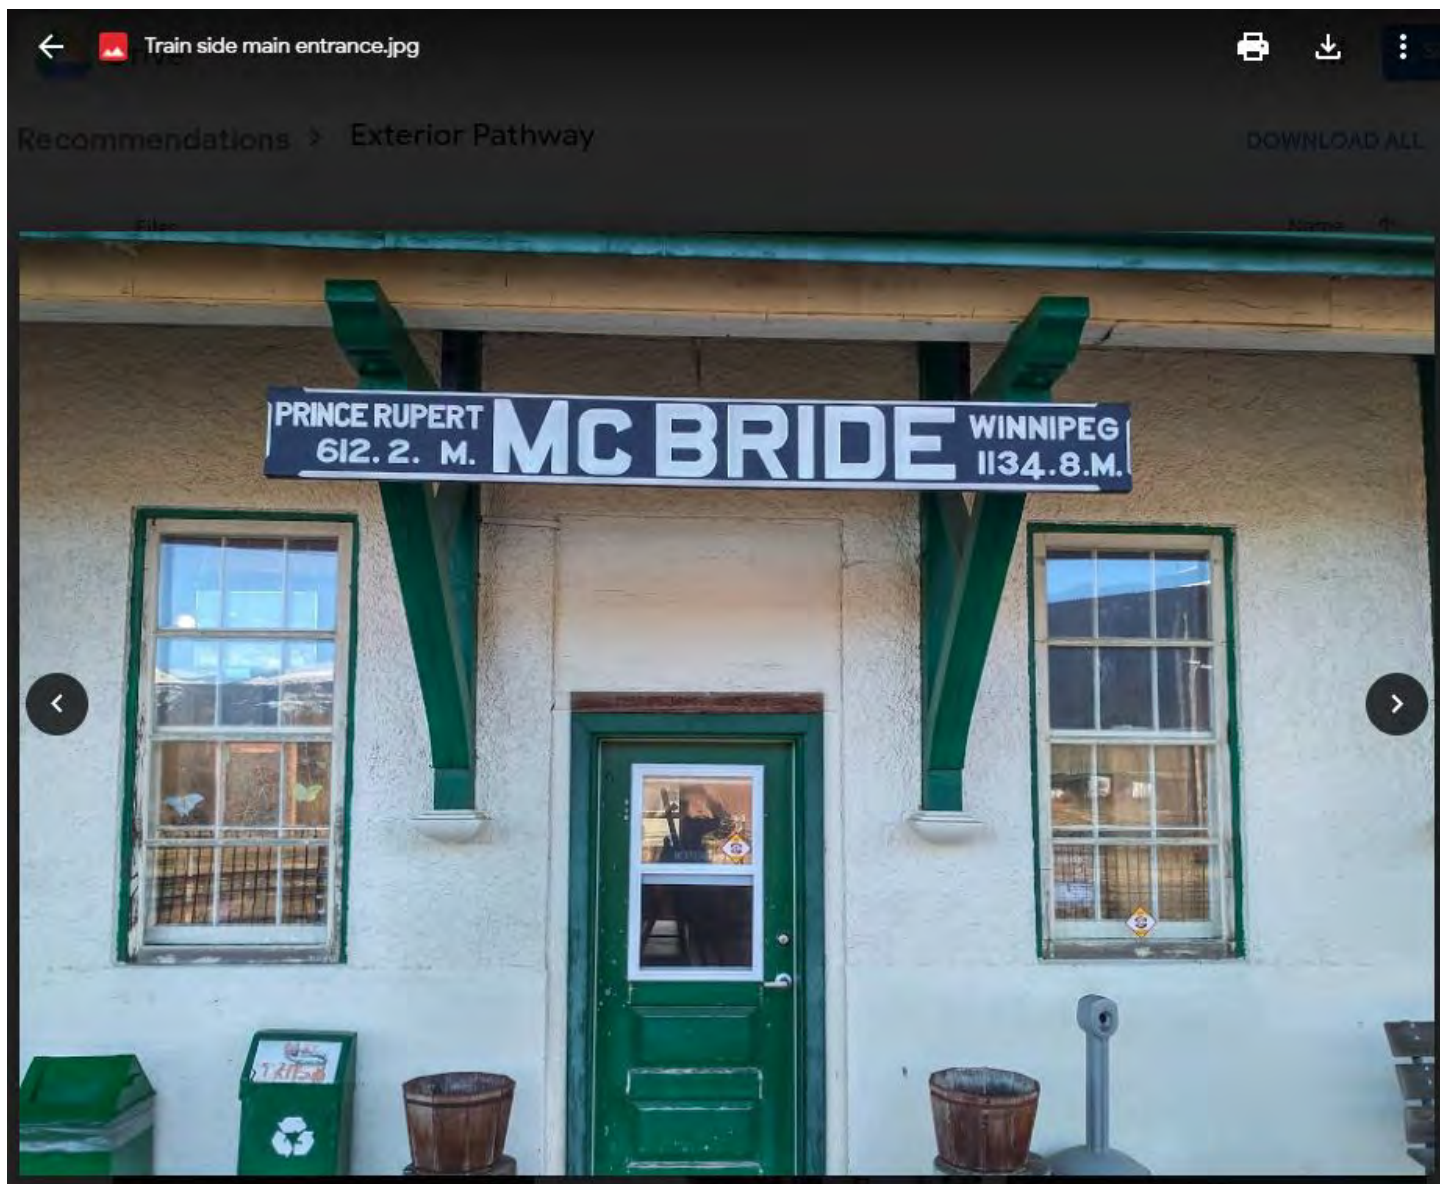
EXTERIOR PATHWAY – Track Side Main Entrance

- The main entrance to the facility on the train side is not easily identifiable. The current signage is weathered and not easy to read. A new sign is recommended along with blade signage to increase visibility to all the amenities (model train exhibit, restaurant, main entrance to Gift Shop Gallery, Information Desk and washrooms.)

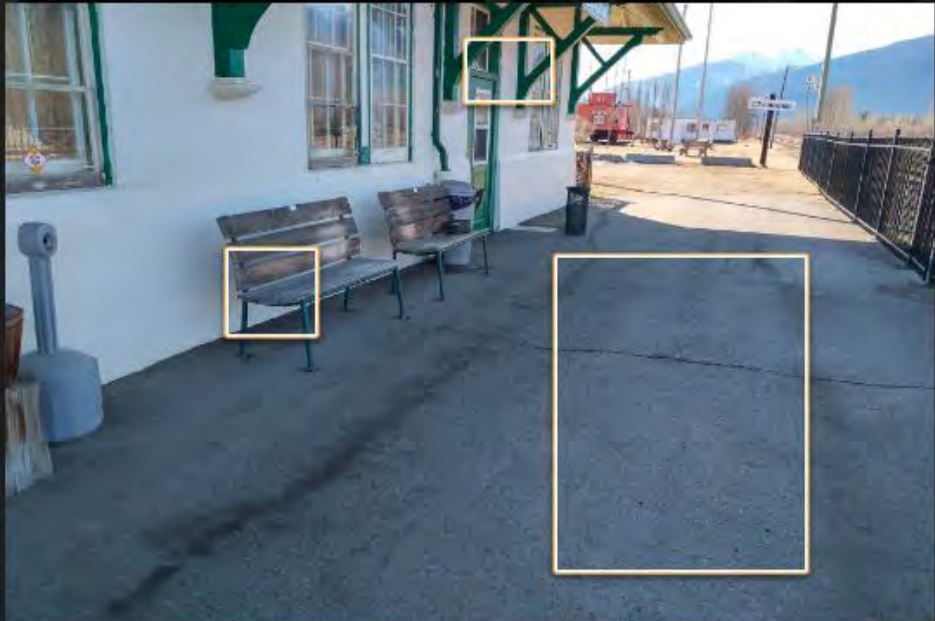
EXTERIOR PATHWAY – Track Side Seating

Ken Kuzminski  
10:47 23 Apr  
Blade signage would increase visibility

Ken Kuzminski  
10:46 23 Apr  
Benches lack the option of arm rests

Ken Kuzminski  
10:55 23 Apr  
Directional indicators can facilitate visitor flow and amenity locations

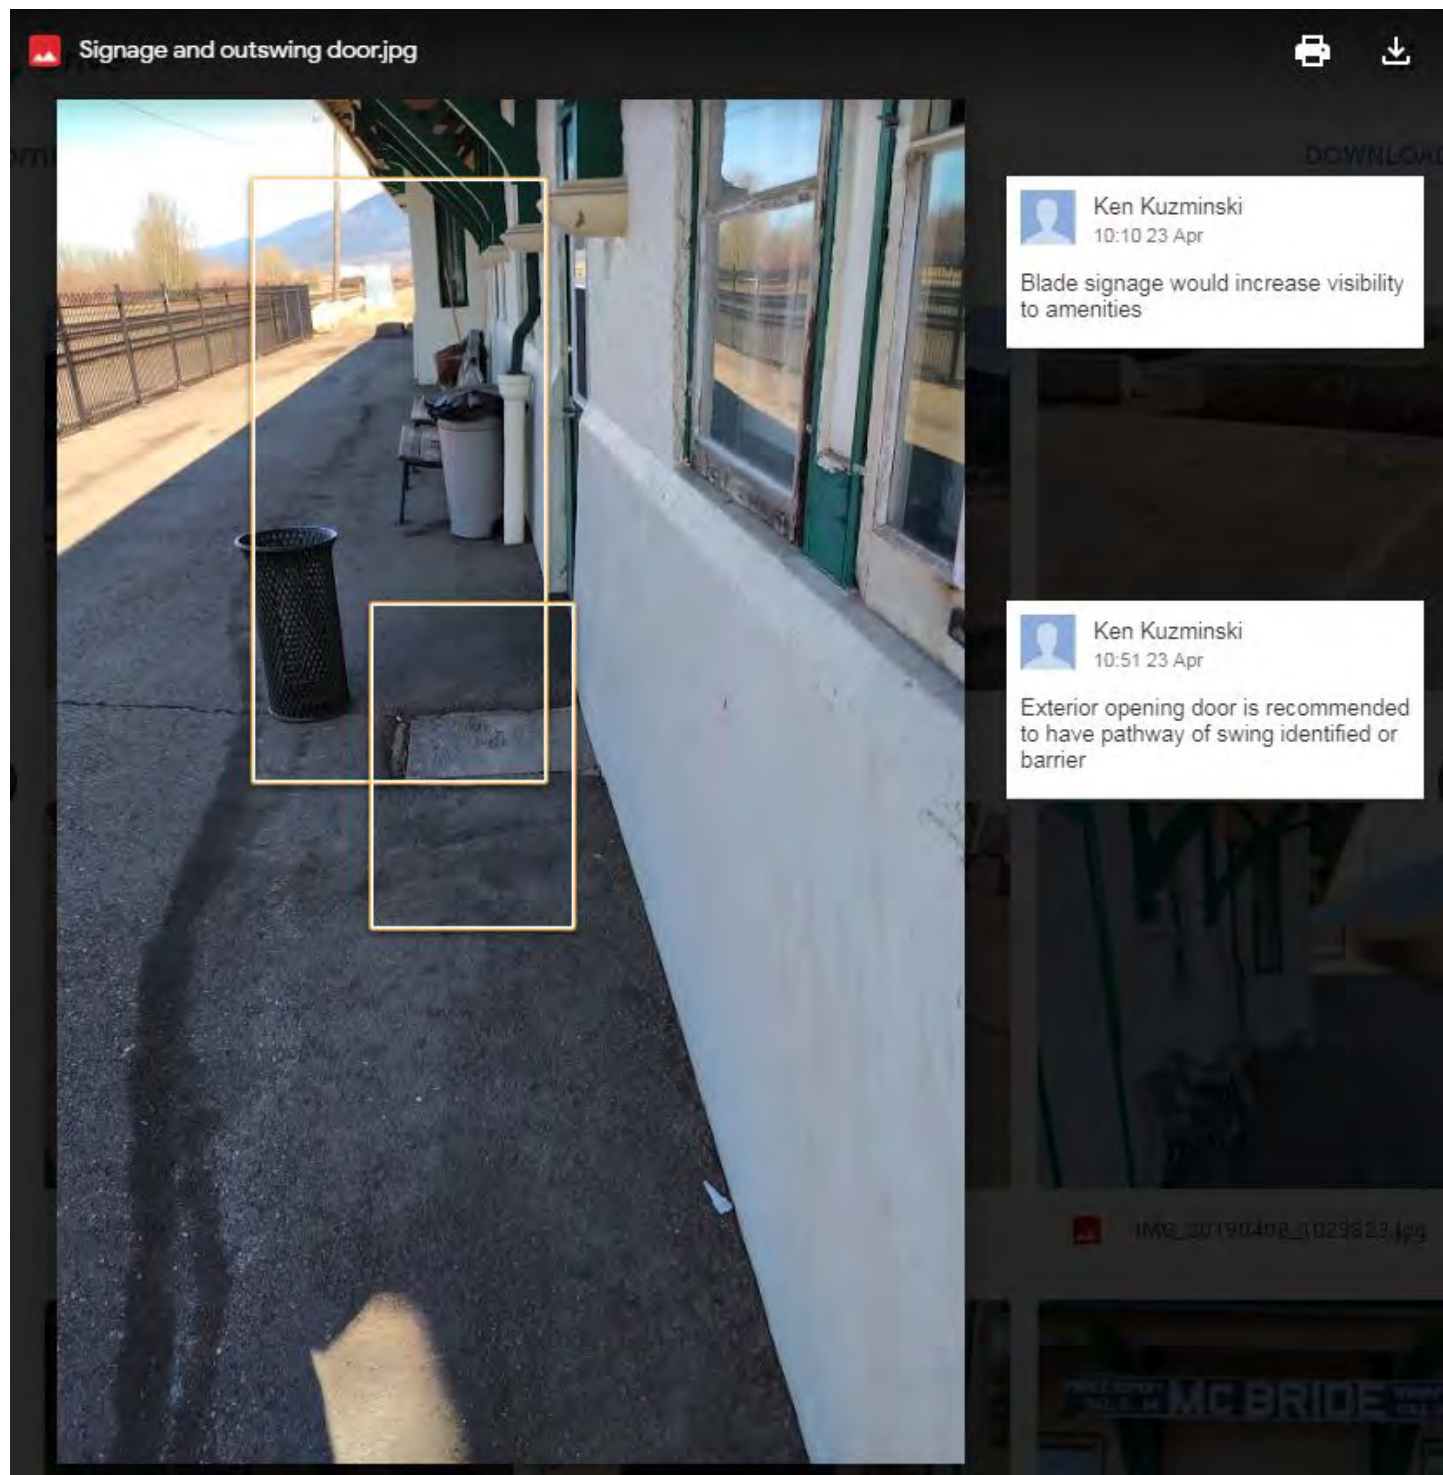
EXTERIOR PATHWAY – Track Side Signage and Outswing Door

- The restaurant door on the track side has a threshold weather stripping that should be changed to a door mounted weather stripping. The door currently swings outwards therefore it is recommended that a barrier (railing) be erected outside to indicate the path of travel.

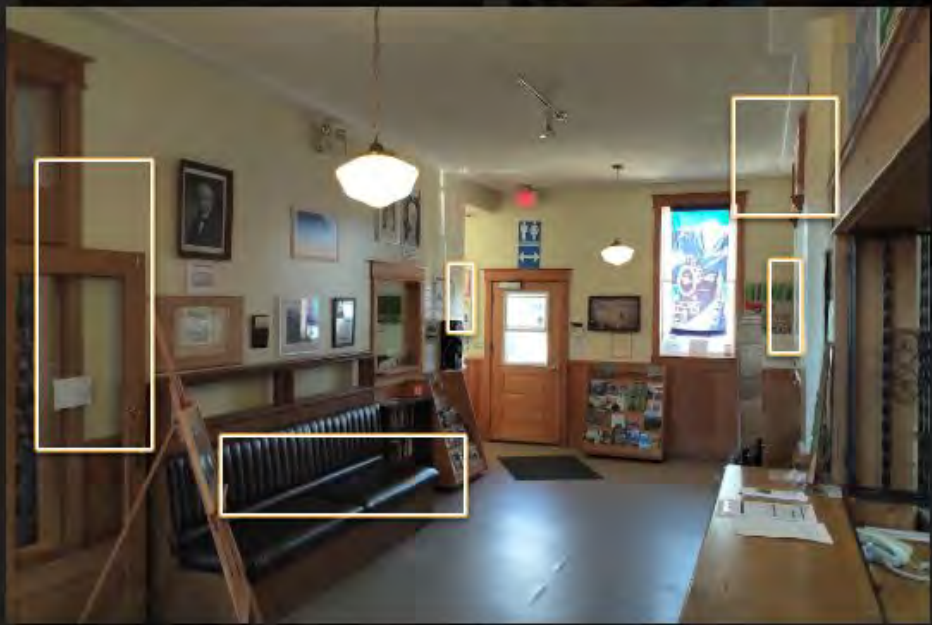
LOBBY INFORMATION – Lobby

Ken Kuzminski  
11:16 23 Apr  
Seating options do not have the option of arm rests

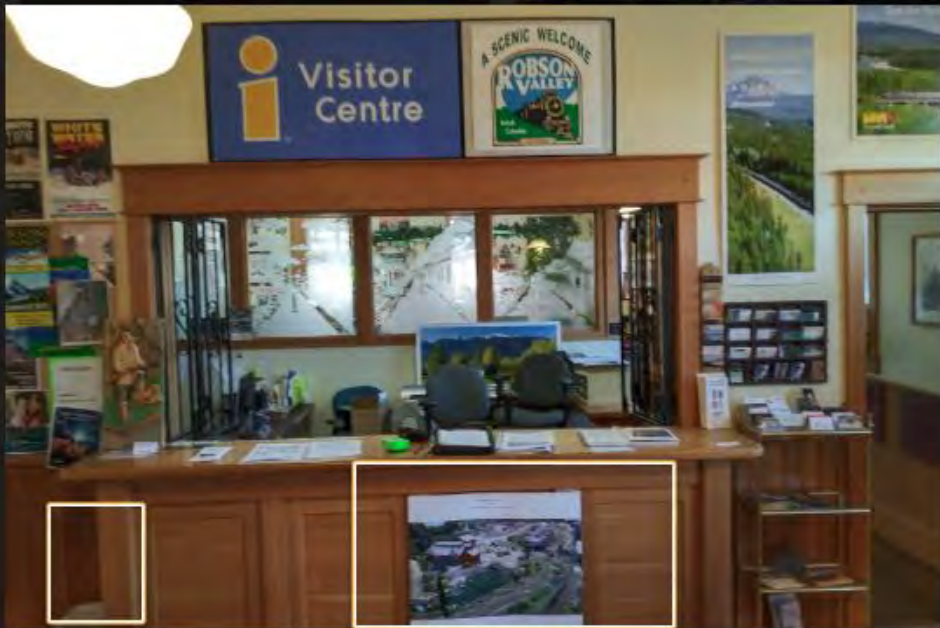
LOBBY INFORMATION – Information Desk

- The Lobby/Reception area is wide and open. The Information Desk is well indicated but is at an elevated level (1100mm). It is recommended to have some area of service desk counter height for accessibility of 860mm. A long term recommendation is to have this renovated to accommodate the service counter height accessibility. Leg room is also recommended for the service counter. When the service counter is renovated, it is recommended that is colour contrasted to the surrounding walls.
- The Lobby does have seating available. It is recommended to add a seating with arms option to assist people in sitting down and standing.
- Directional Signage for the restaurant access from the Lobby is recommended as is directional signage to the Model Train Exhibit.
- There is a lacking of signage for the Gift Shop/Gallery in the Lobby. It is recommended that signage at the entrance of the Gallery.

Information desk blends into the surroundings. It is recommended that it is a contrasting colour.

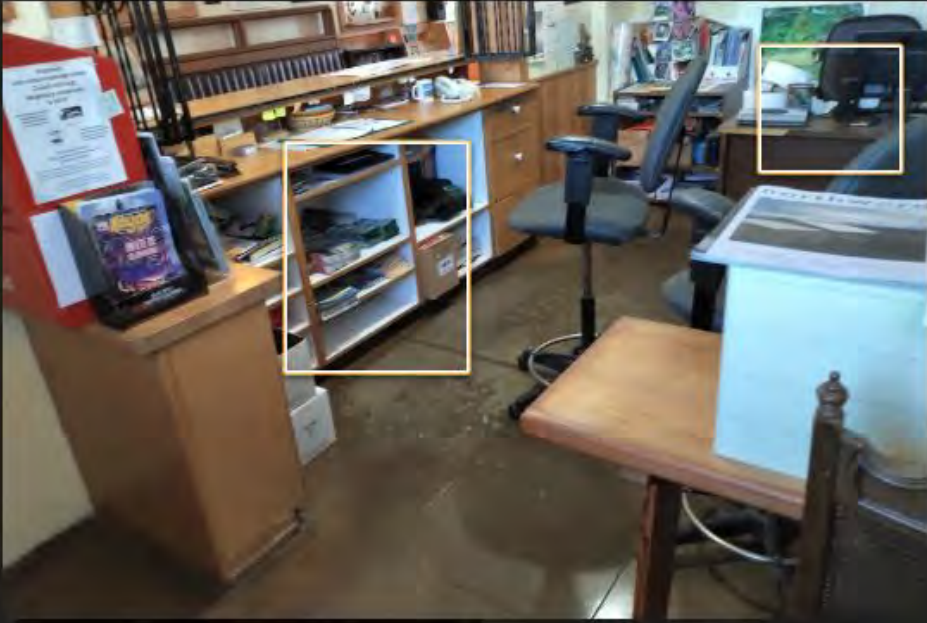
- The work stations behind the Information Desk is limited for space. At the time of the assessment the space was not occupied. It is recommended from the assessment that the space may be opened up to provide greater access by having all the desks along the outer walls of the work area and keeping the centre area clear for access. This is an initial recommendation. A more in depth consultation would have to be done with management to interpret how the space is utilized.
- The workstation for the Gift Shop/ Gallery is set up along one wall with clear space access. The lunch room/ coffee room had lights that were not working at the time and could be hazardous to employees. It is recommended that the lights be replaced/repared.
- I also recommend that any renovations have the electrical outlets be placed a 400mm to centre and switches be placed at 1200mm.

Access to this desk is congested. It is recommended that it be reversed and face the wall for increased access.

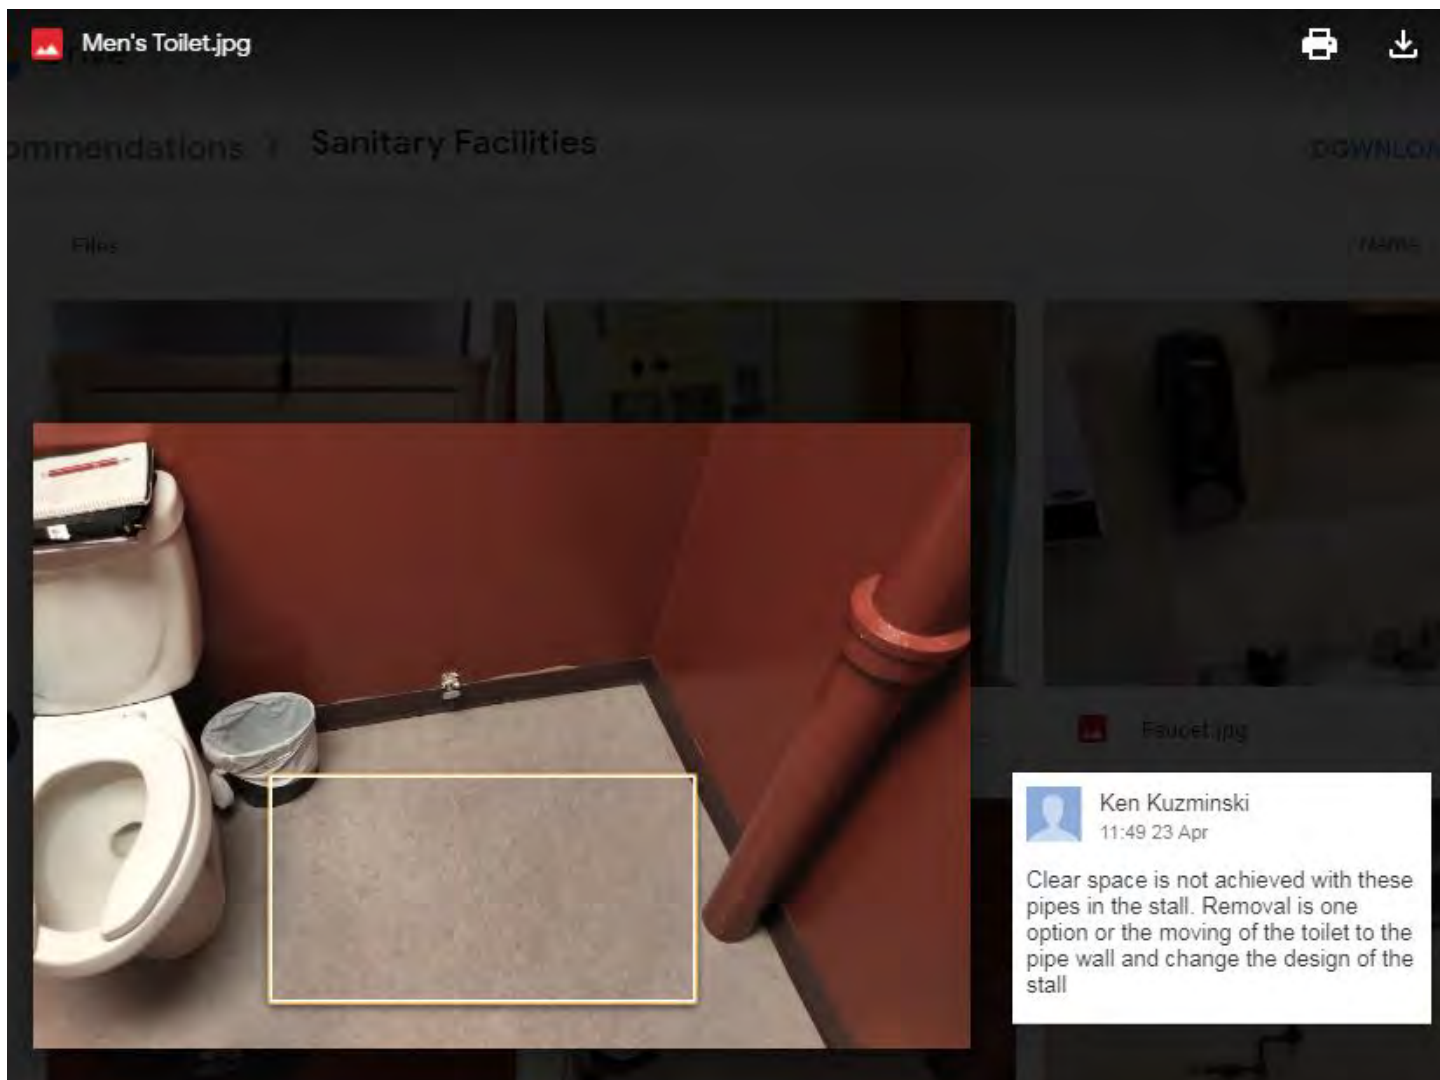
WASHROOMS – Men's Toilet

- The stalls in the washrooms do not have a sufficient size with the accessible turning radius to 1500mm or greater. There is a sewer vent or pipe in the stall that limits the radius. It is recommended to remove or change location of pipe to increase radius. Alternatively a longer term

- solution would be to move the water closet to back onto that wall and thus the pipe would be in a location that would not affect the clear radius.
- The coat is recommended to be moved to a height of 1200mm. The current height is 1800+mm. The latch and door pull is recommended to be lowered to 950+/-50mm. The latch is currently small difficult to grasp. It is recommended to install a sliding latch that is easily moved with a closed fist. The door pull is recommended to be D-shaped and installed horizontally and 200-300mm from hinge side of the door.

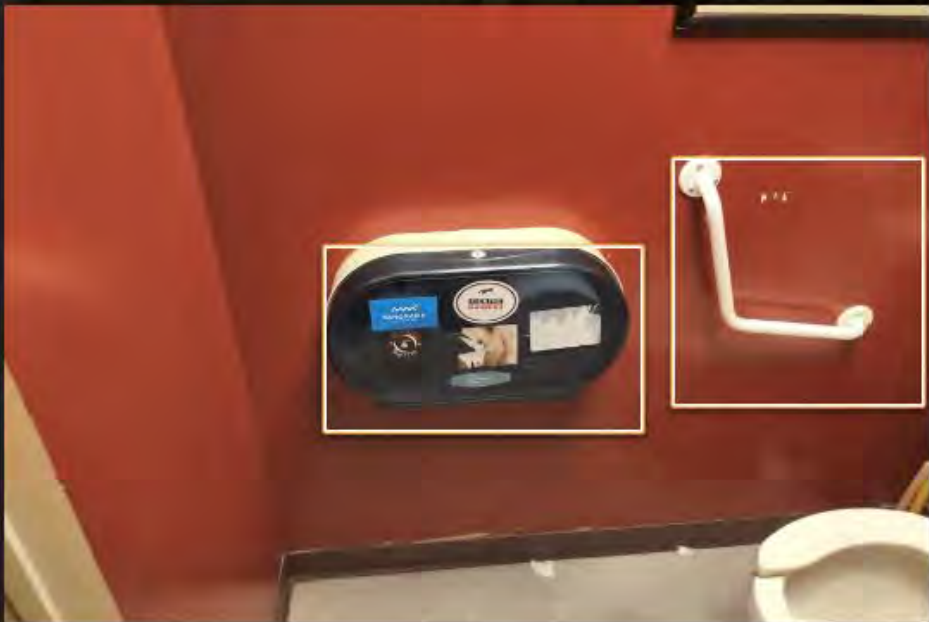
WASHROOMS – Men's grab bars and dispenser

- The grab bars should have a diameter of 30-40mm and a clearance of 35mm. They shall be installed with the centerline 300-330mm above the water closet and be 600mm horizontally then rise at a 60 degree angle for another 600mm. The transition from the horizontal to 60 degree angle is recommended to line up with the front of the water closet. It is recommended that an additional grab bar of 600mm be install above the tank and centered on the water closet.

Grab bar shall be textured for grip. It shall be horizontal 300mm above the seat and run 600mm back from the front edge of the toilet and rise at a 60 degree angle from the front edge of the toilet. and be 600mm in length.

toilet paper dispenser is recommend to be installed as close to the front edge of the toilet and be below the height of the horizontal grab bar and allow access.

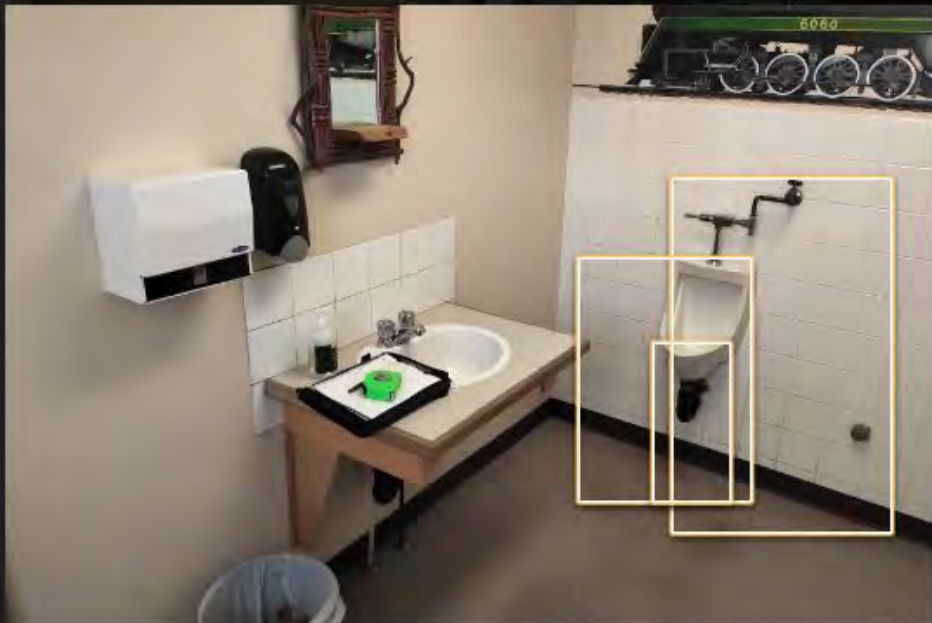
WASHROOMS – Urinal 2

- The toilet paper dispensers are recommended to be installed in line with the front edge of the toilet below grab bar.
- The Urinal is recommended to install grab bars on either side of the fixture. The Urinal is current at a height (650mm) exceeding the accessible basin height of 500mm +/-12mm. It is a long term recommendation to install a second urinal at the recommended height to help with capacity and accessibility. The surrounding tile should be of a contrasting colour. A clear width of 800mm from centre of fixture is needed for each urinal. The basins currently does not have accessible or automatic faucets. It is recommended that these are replaced with the appropriate lever action faucets.

Urinal is the same colour as the surrounding wall. Contrasting colour is recommended

Basin Height is above the recommended height

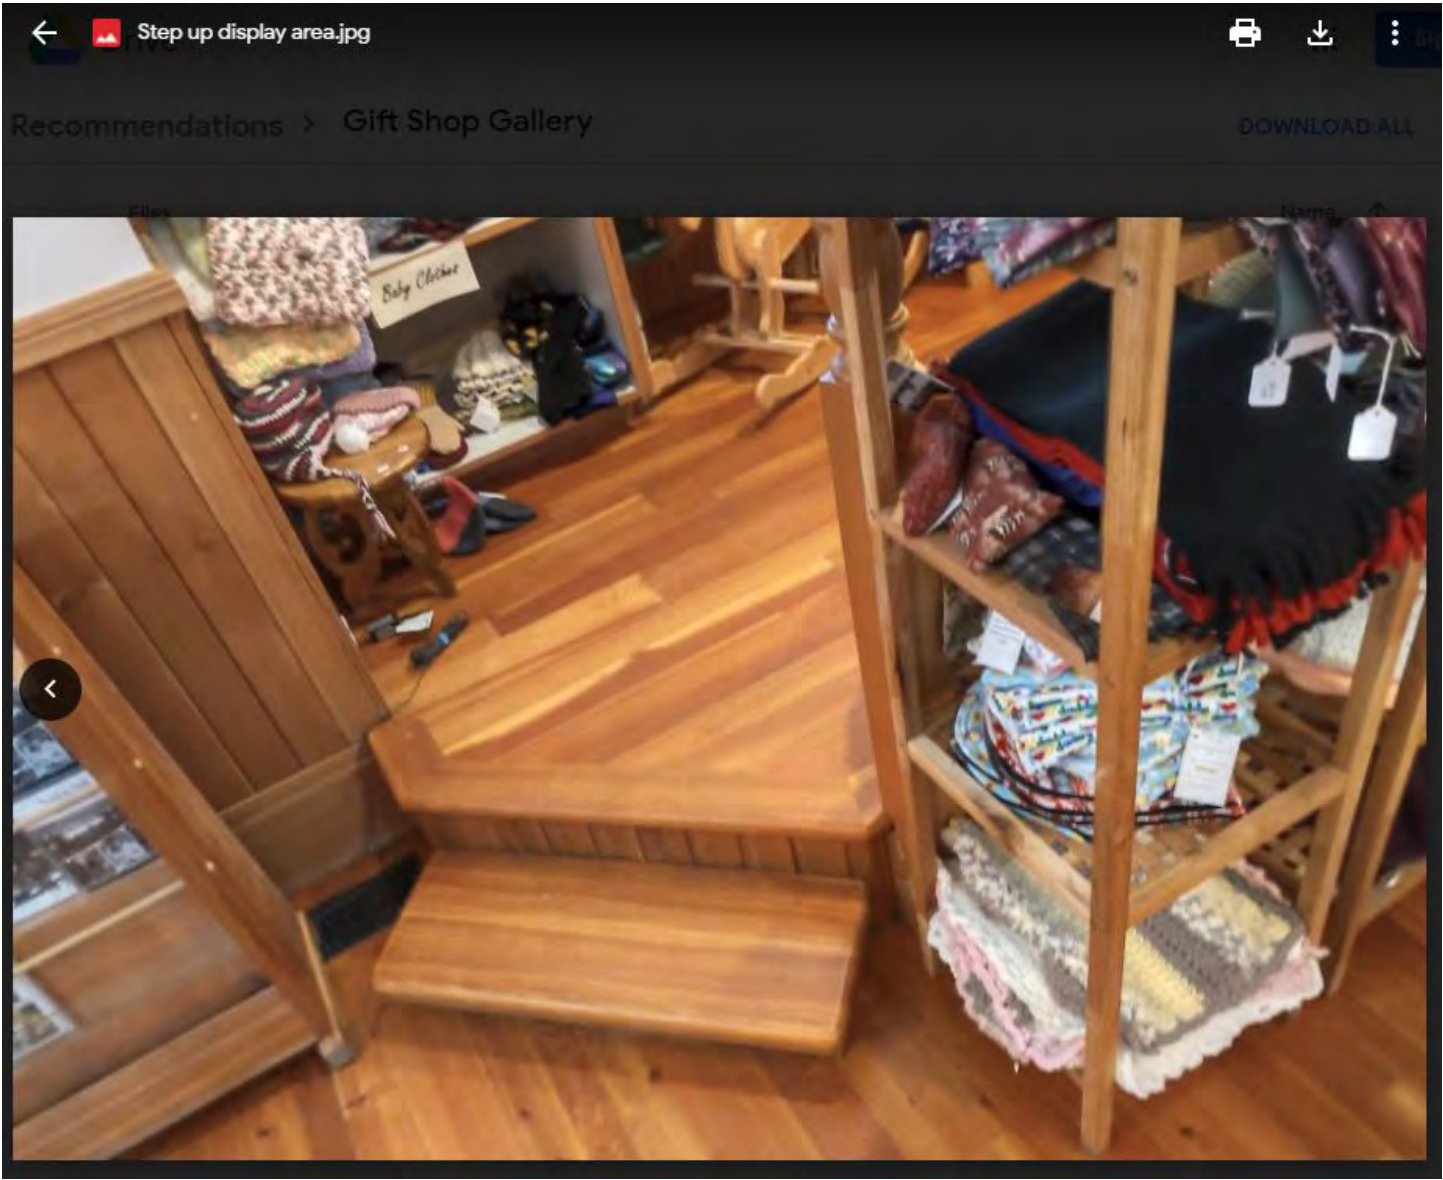
GALLERY/GIFT SHOP – Step-Up Access

- The Gift Shop/ Gallery is set up with ample space to maneuver and access to displays. The areas of concern for accessibility in this space is the one step raised area that creates a barrier to people with mobility. A long term solution would be to remove the raised area.
- A short term solution would be to have a 70% colour contrasting nosing installed to prevent a tripping hazard.
- The Point of Sale (POS) Desk is at a height that is not conducive to accessibility. The counter is currently at 1200m. It is recommended that a section of the counter be reduced to 860mm to increase accessibility.

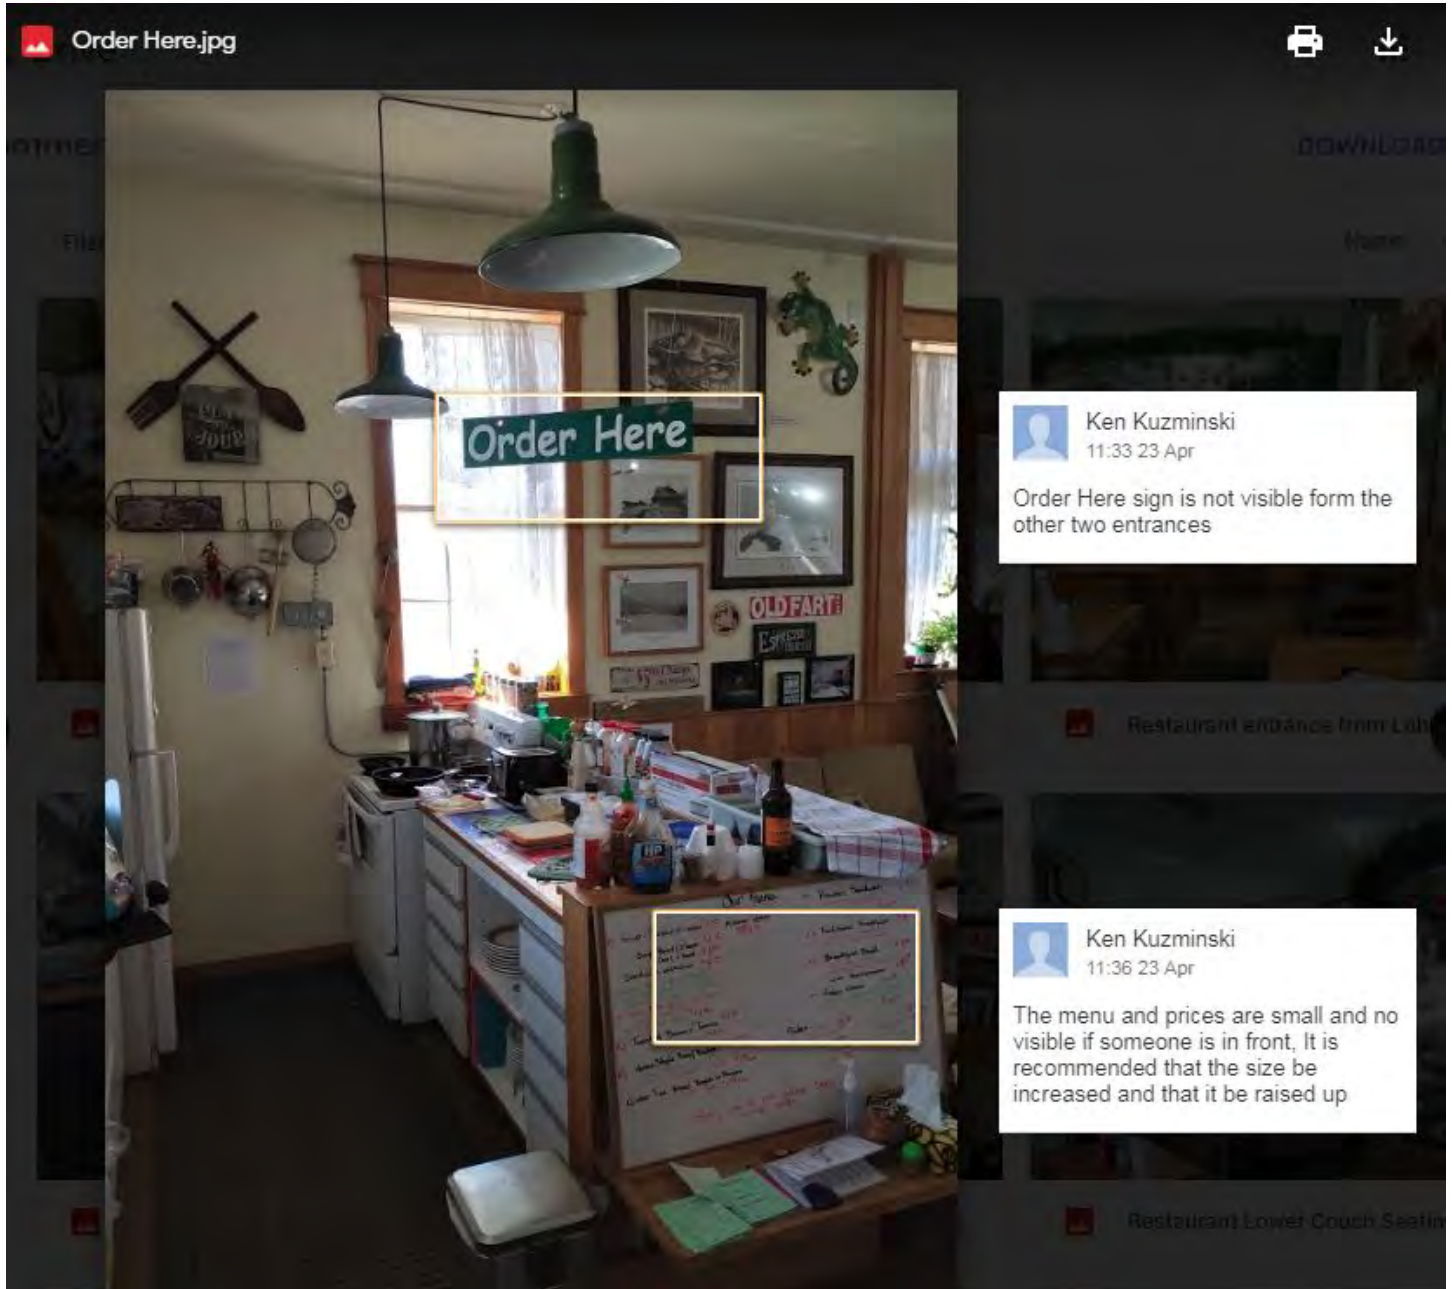
RESTAURANT – Order Here Signage

- The Signage and Wayfinding in the restaurant is insufficient. The Order Here sign and the Cashier sign are not visible from all the entry points. To help inform and reduce confusion when entering, signage that is visible in

12.1. Signage – The Order Here Sign is not Visible from all directions. This can be corrected by having a double sided sign and an increase in size. The Cashier Sign could have additional signage to be visible from the train entrance.

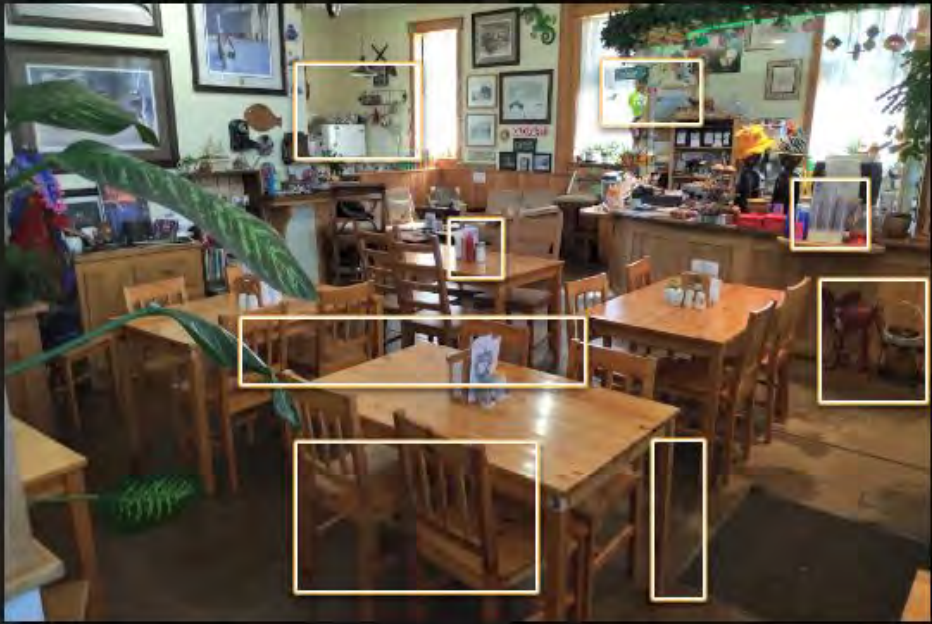
RESTAURANT – Seating

- The tables in the restaurant are congested when occupied. A solution would be to have a designated seating that allows for extra room.
- The restaurant staff are extremely helpful but access to all amenities such as the coffee and cream and sugar is limiting and could be moved to provide ease of access. This could be done by lowering the shelf and moving the products.

Ken Kuzminski  
11:40 23 Apr  
Cashier is partially visible but can get lost within the other hanging items

Ken Kuzminski  
11:39 23 Apr  
Order Sign is not visible so it causes confusion to how to proceed in the restaurant.

Ken Kuzminski  
11:38 23 Apr  
Added items on the floor can be a barrier

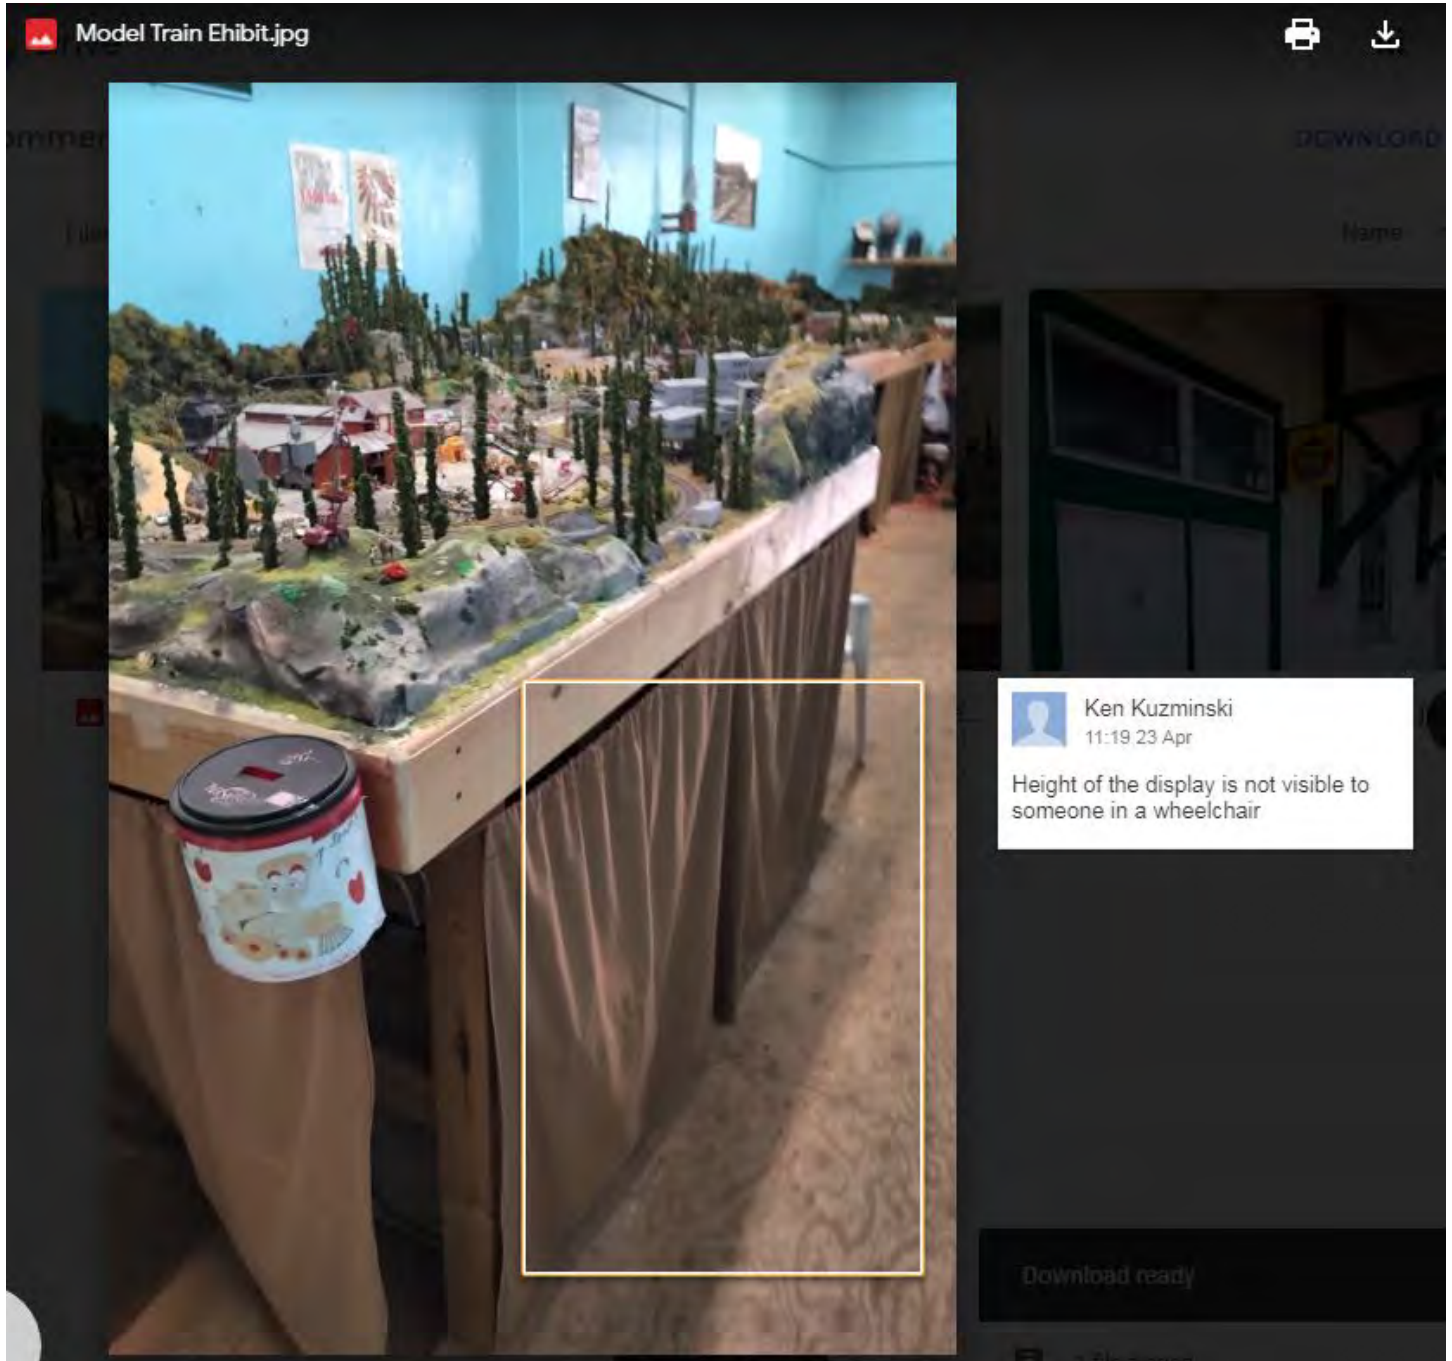
MODEL TRAIN EXHIBIT – Height of Exhibit

The Model Train Exhibit Space entry was discussed above. The current elevation for the model display is approximately 1200mm to the base. To see the display you have to be above this height. A long tem solution would be to lower the display. Access to an elevated platform would be restricted.
