# MOVING TOWARDS UNIVERSAL ACCESS

## **Accessibility Recommendations for the McBride Train Station**

Apex Access Consultants

# Village of McBride Historic Train Station

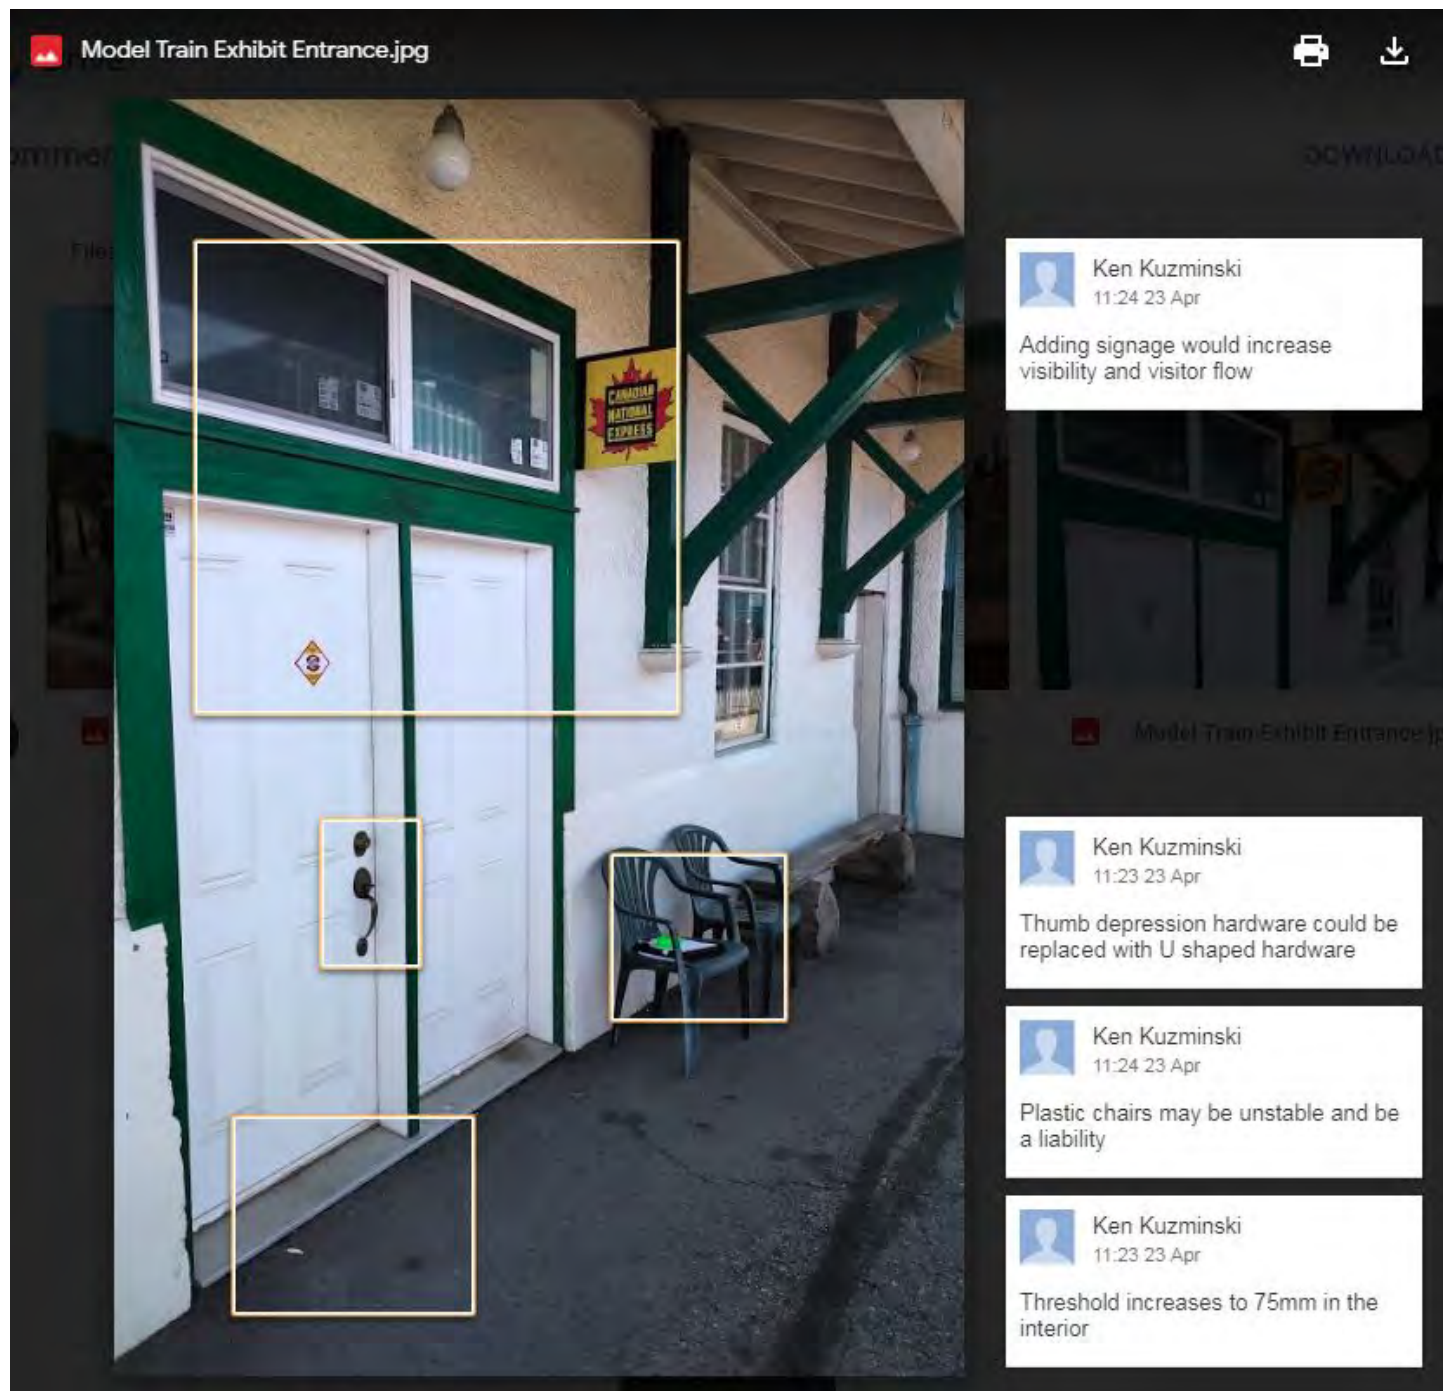
MODEL TRAIN EXHIBIT – Exterior Entrance

- The door to the Model Train Exhibit is not accessible. The current threshold is near to 75mm. The door currently has a thumb depression handle. These situations keep this space from being accessible. The

recommendation in the long term is to replace the door style to one with a level threshold and assessable hardware. In the meantime, a temporary exterior grade rubber ramp can be installed on both sides of the entry doors and accessible U-shaped hardware installed. The ramps approximately cost \$250 each depending on the sizes.
