# MOVING TOWARDS UNIVERSAL ACCESS

## **Accessibility Recommendations for the McBride Train Station**

Apex Access Consultants

# Village of McBride Historic Train Station

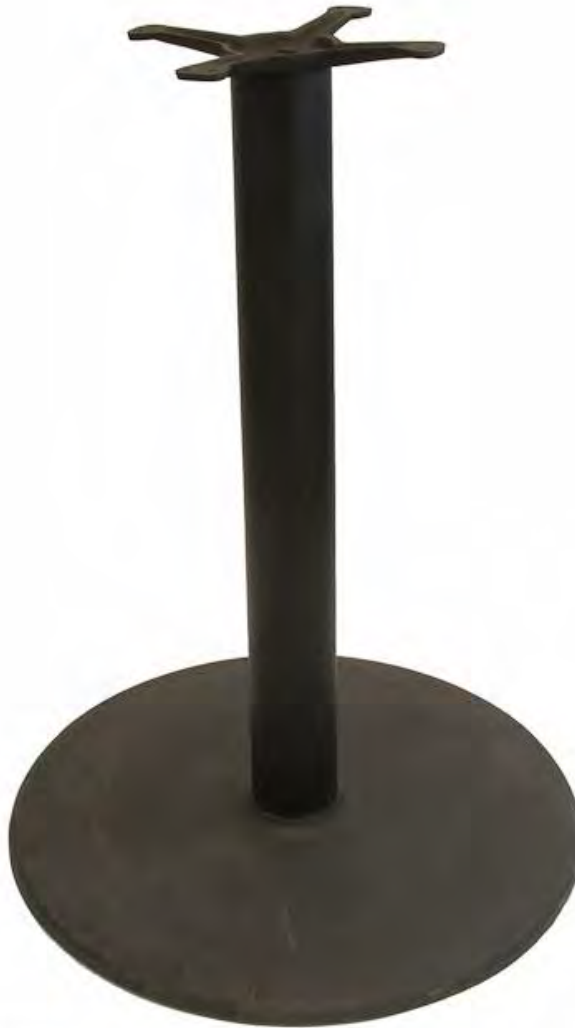
- 12.2. Tables – Tables with corner legs cause a barrier for wheelchairs and walker. A pedestal style table base is recommended.

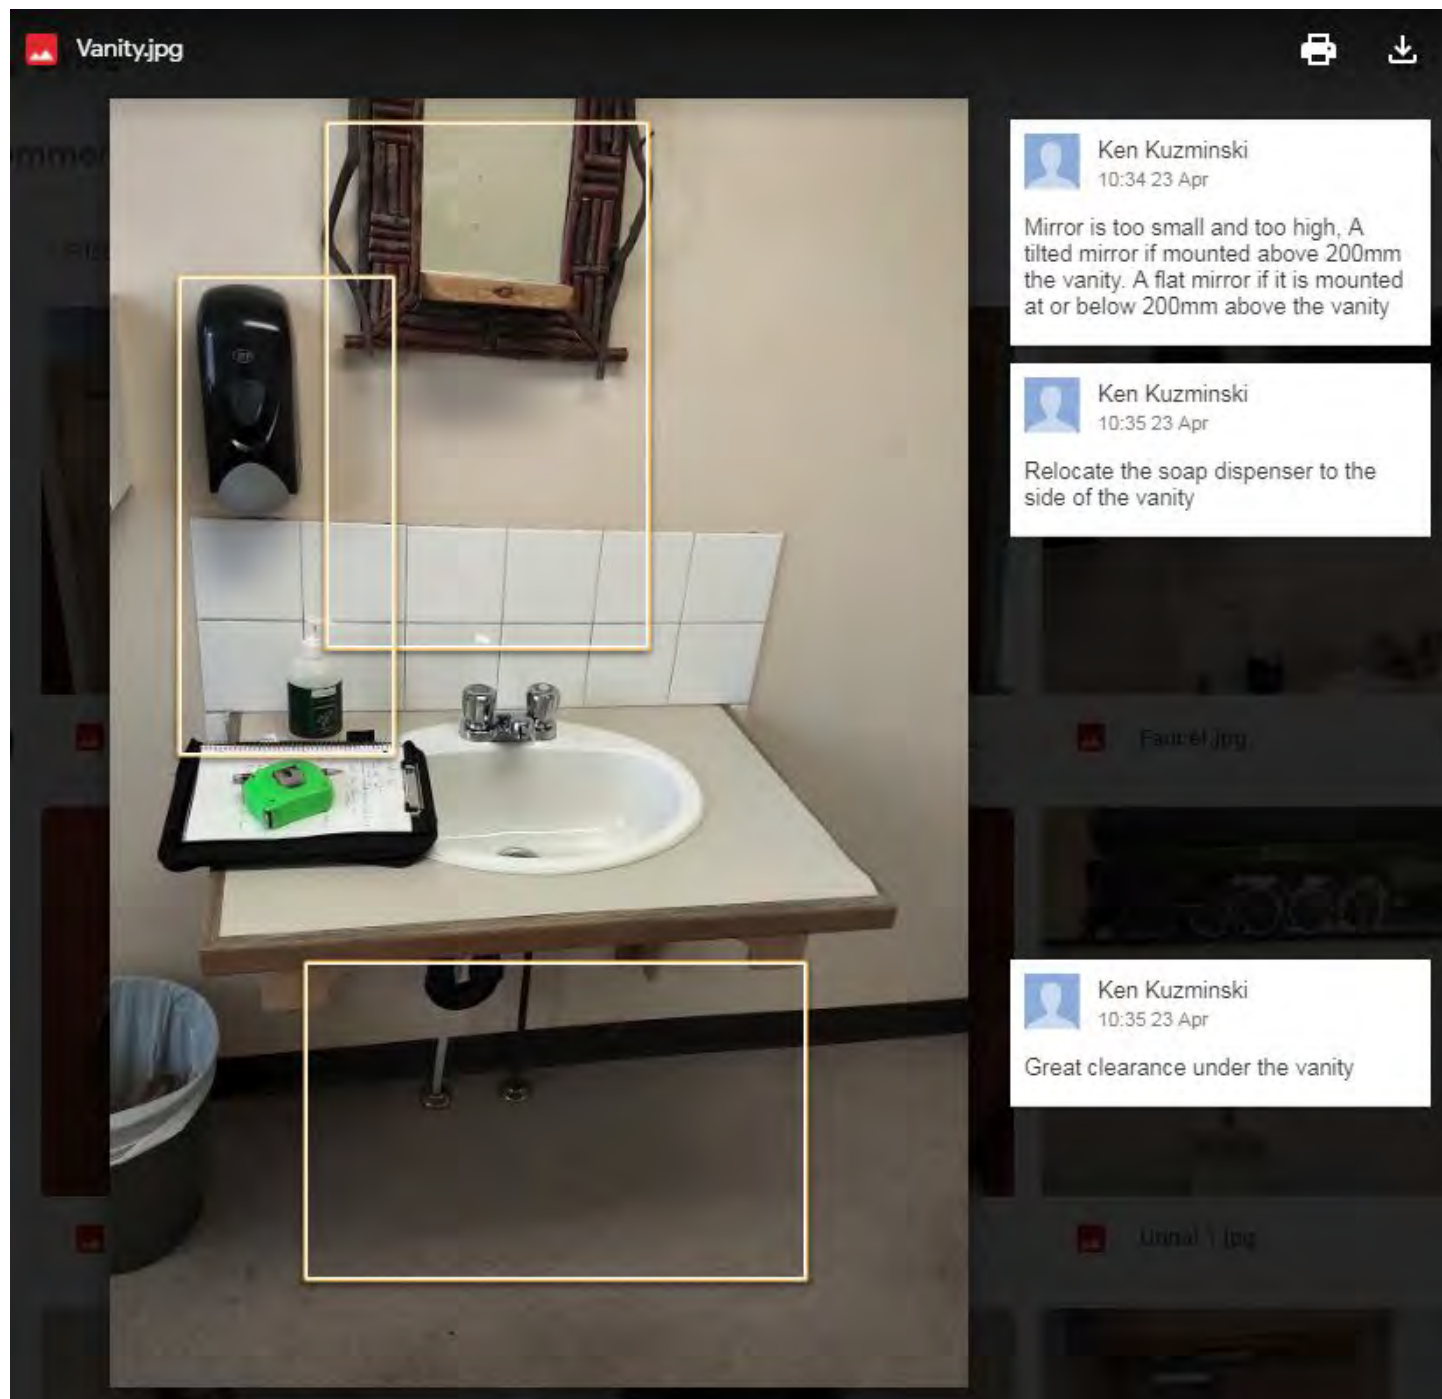
WASHROOMS – Men's Vanity

- The hand soap dispenser and paper towel dispensers are recommended not to be directly over the vanity. This blocks access and is recommended to be moved over beside the vanity.

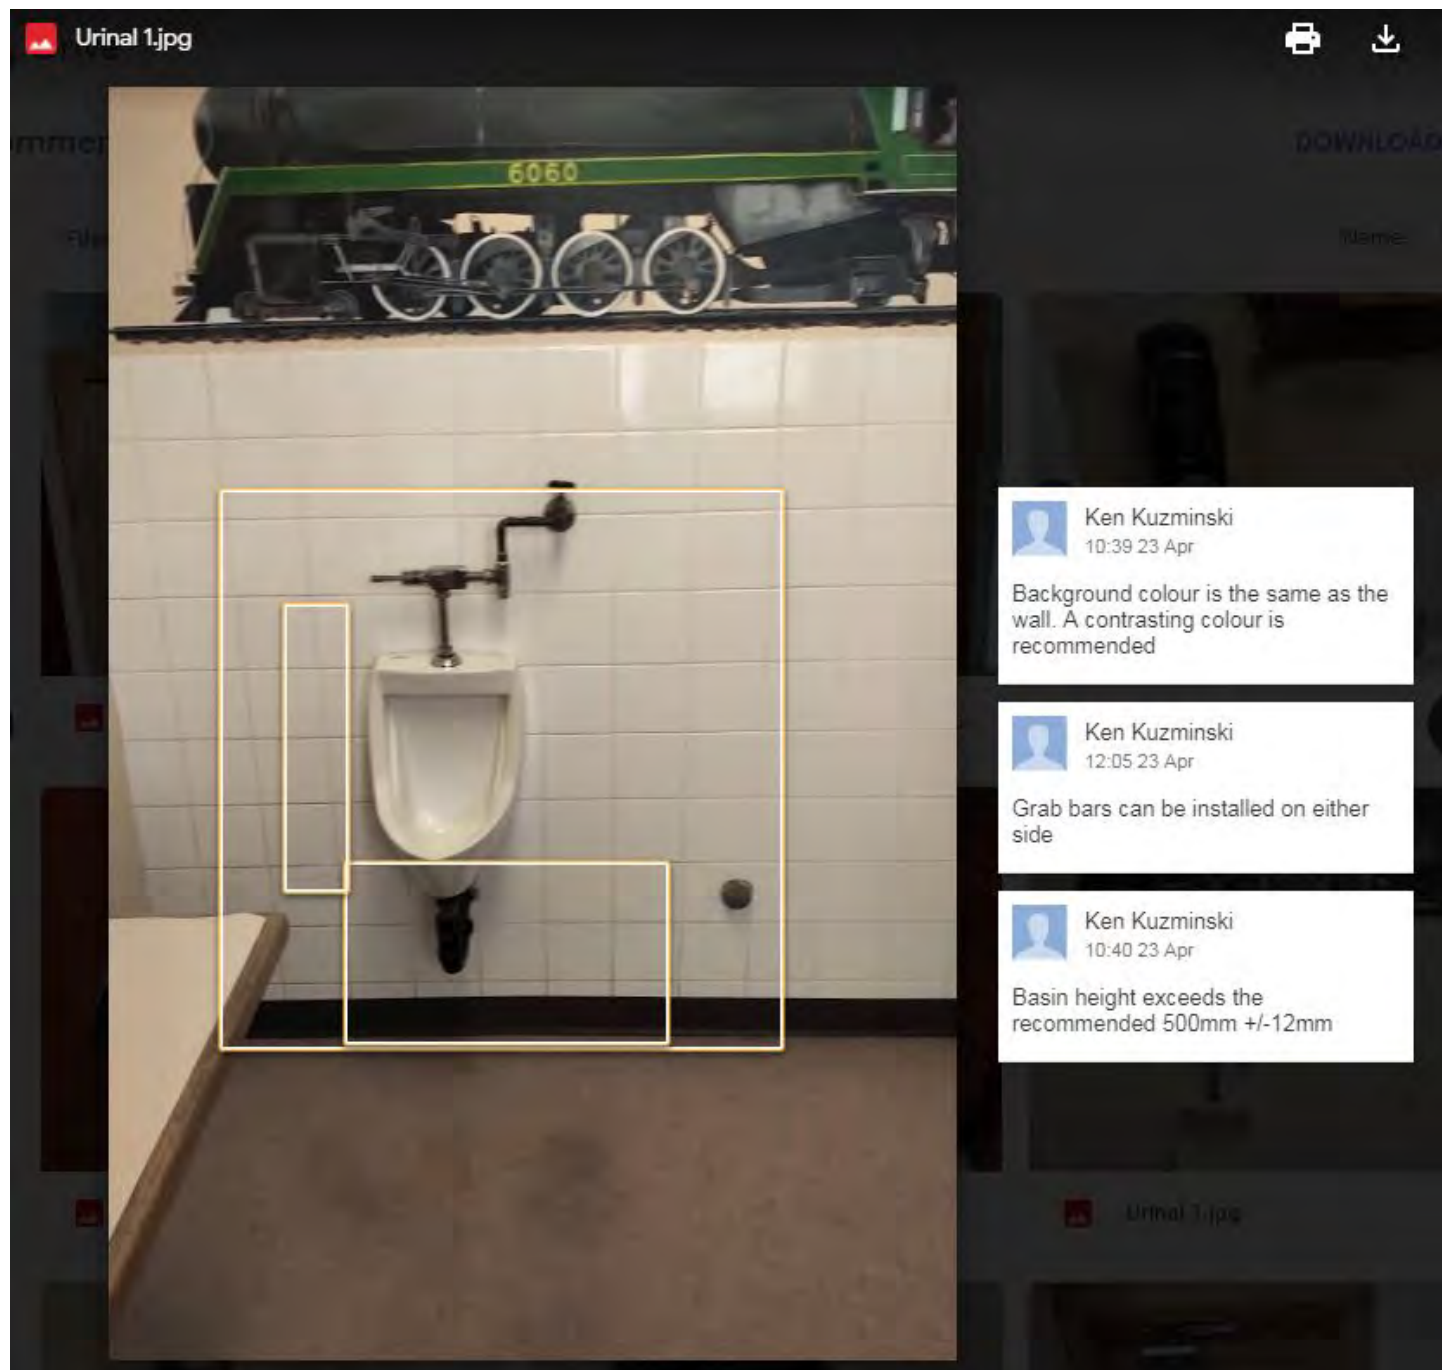
WASHROOMS – Urinal 1

- The toilet paper dispensers are recommended to be installed in line with the front edge of the toilet below grab bar.
- The Urinal is recommended to install grab bars on either side of the fixture. The Urinal is current at a height (650mm) exceeding the accessible basin height of 500mm +/-12mm. It is a long term recommendation to install a second urinal at the recommended height to help with capacity and accessibility. The surrounding tile should be of a contrasting colour. A clear width of 800mm from centre of fixture is needed for each urinal. The basins currently does not have accessible or automatic faucets. It is recommended that these are replaced with the appropriate lever action faucets.

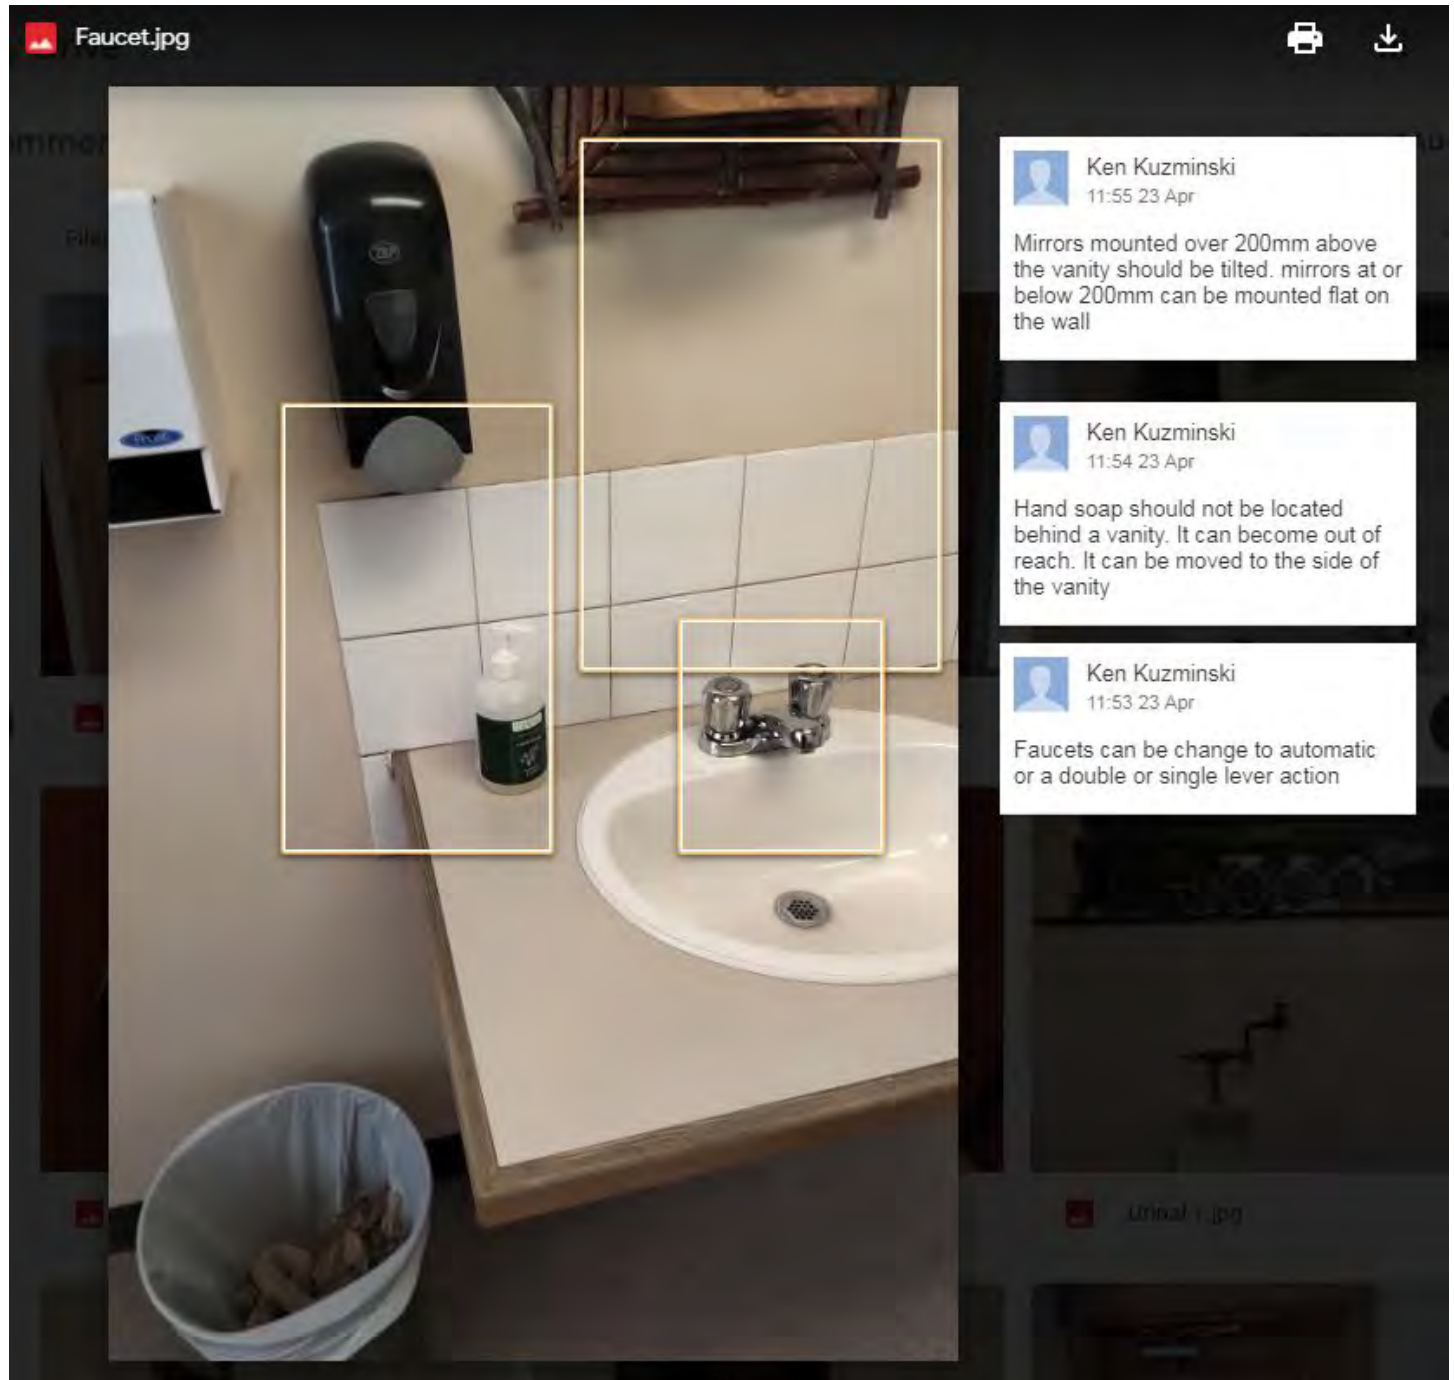
WASHROOMS – Men's Vanity

- Mirrors in the washrooms are recommended to be changed out. The height for the bottom edge is recommended to be no greater that 1000mm

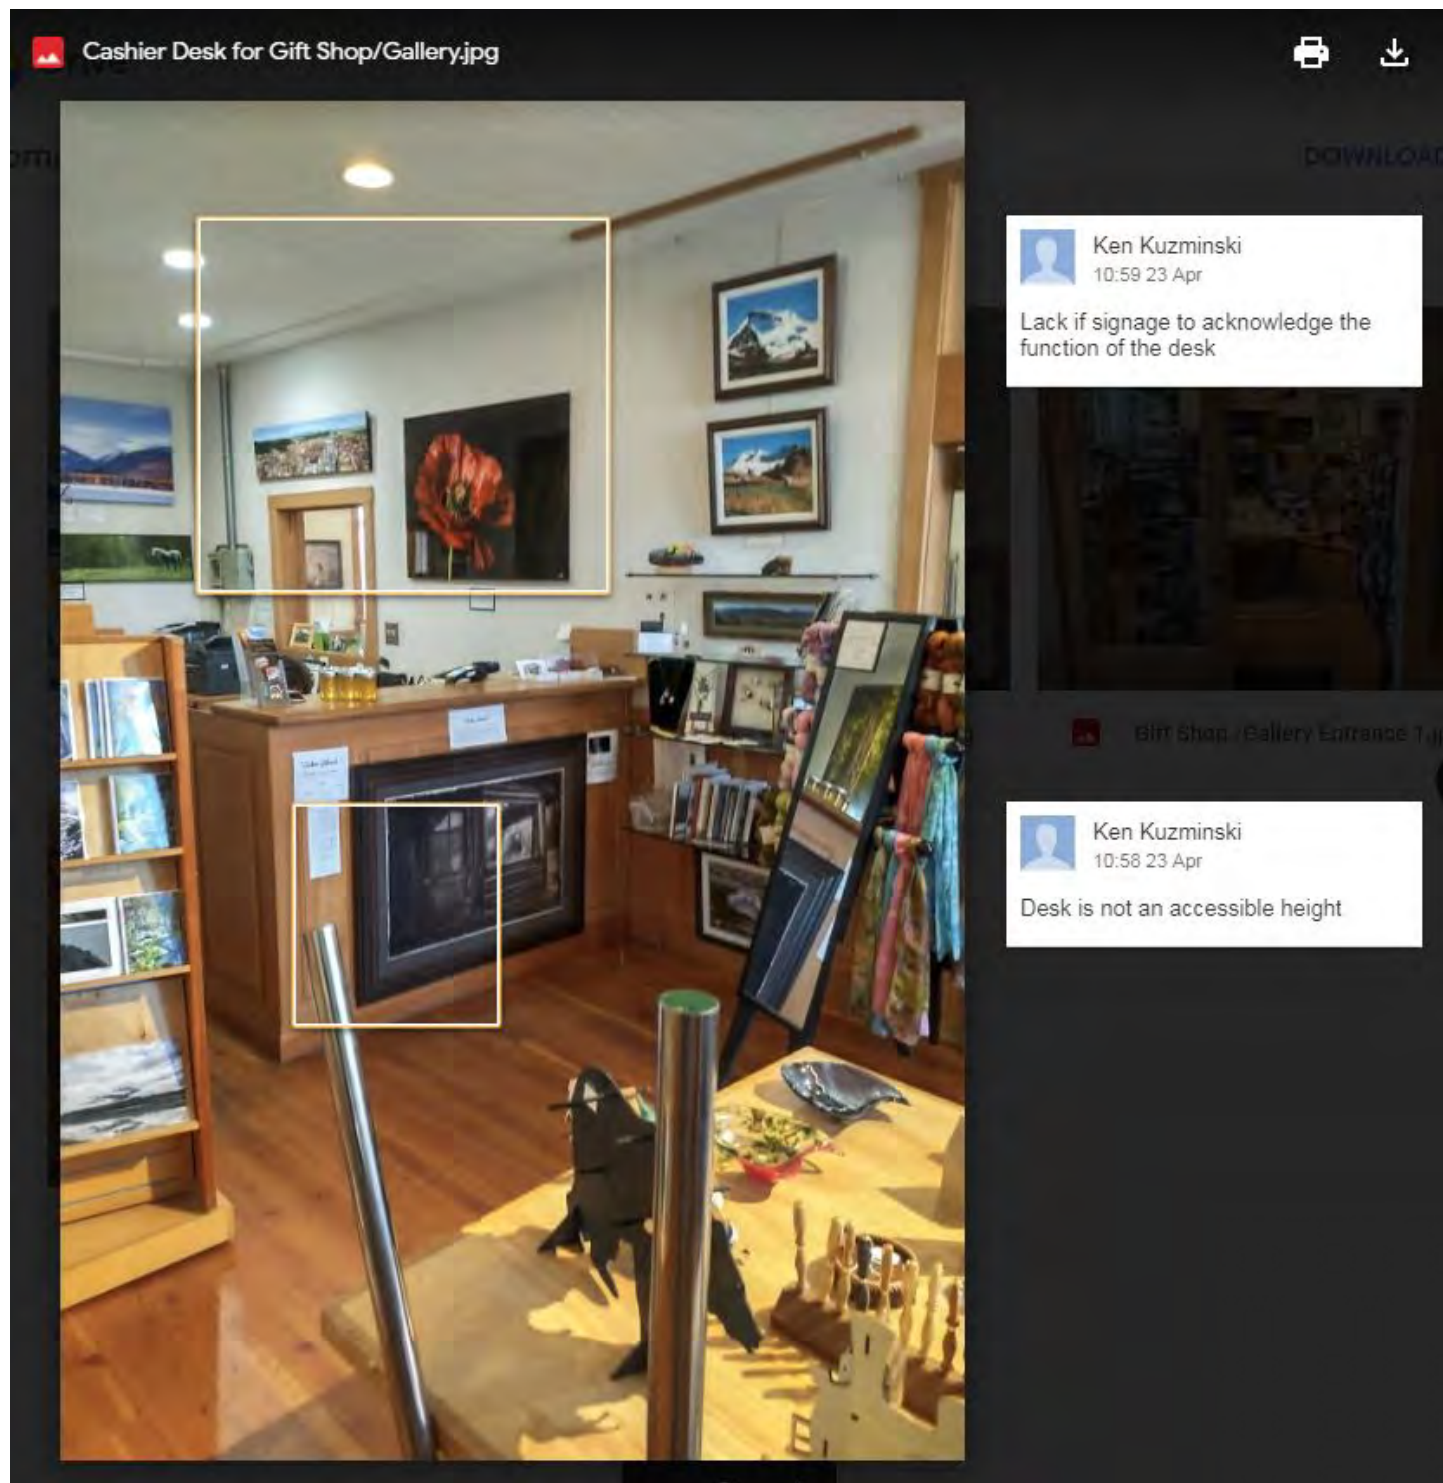
GALLERY/GIFT SHOP – Cashier Desk

- The Gift Shop/ Gallery is set up with ample space to maneuver and access to displays. The areas of concern for accessibility in this space is the one step raised area that creates a barrier to people with mobility. A long term solution would be to remove the raised area.
- A short term solution would be to have a 70% colour contrasting nosing installed to prevent a tripping hazard.
- The Point of Sale (POS) Desk is at a height that is not conducive to accessibility. The counter is currently at 1200m. It is recommended that a section of the counter be reduced to 860mm to increase accessibility.

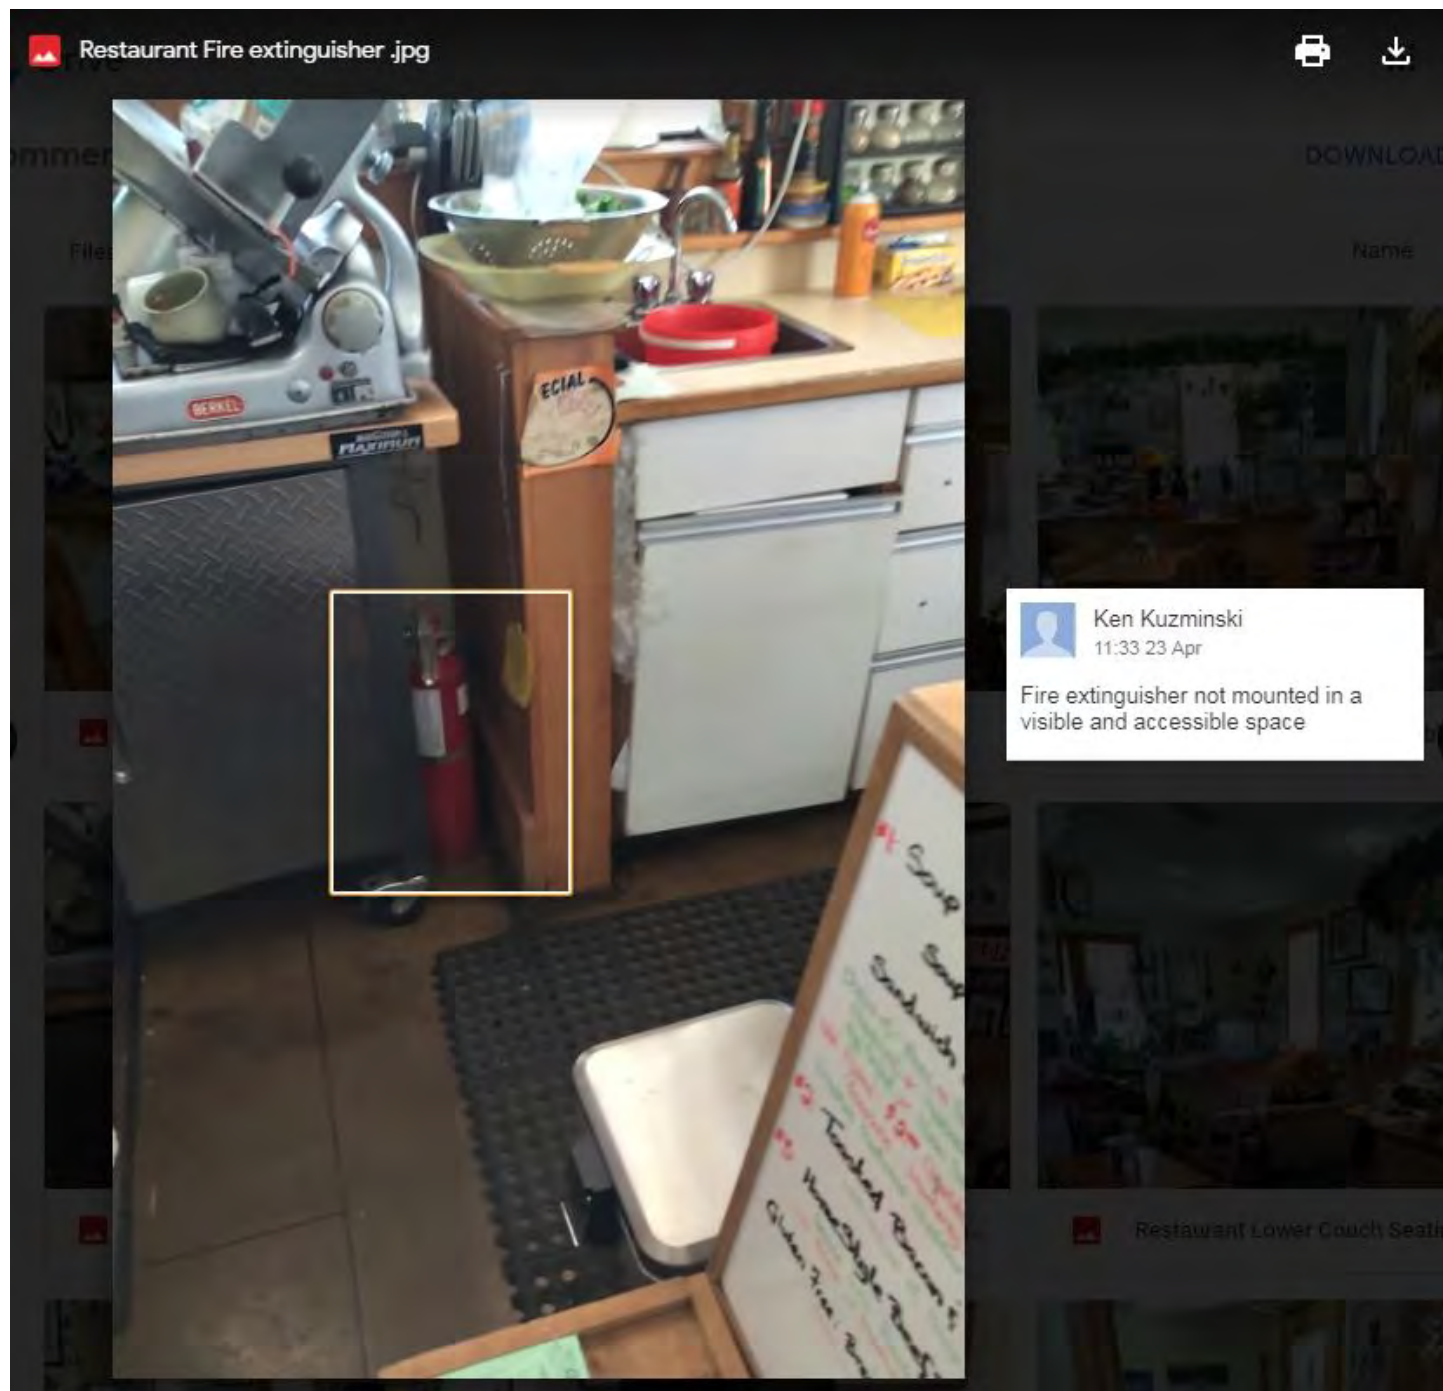
RESTAURANT – Fire Extinguisher

- At the time of the assessment the facility was electronically monitored for security with heat, smoke and CO2 detection.
- There were two fire extinguishers on site that were noticeable. One was in the kitchen under a counter and the other mounted high in the Model Train Exhibit Space. It is recommended that all fire extinguishers are mounted on the wall at a height of 1200mm.
- The exit signs are located on the ceiling or a high location. It is recommended that exit signs are lowered because once an area is filled with smoke, the signs are no longer visible in the ceilings.
- A long term recommendation would be to include visual alarm indication and pull stations at the exit points. If there is a fire in the Kitchen, can we immediately notify people in the Model Train Exhibit?
